# SOHO's Recovery

## – An Unprecedented Success Story

### F.C. Vandebussche

Scientific Projects Department, ESA Directorate for Scientific Programmes,  
ESTEC, Noordwijk, The Netherlands

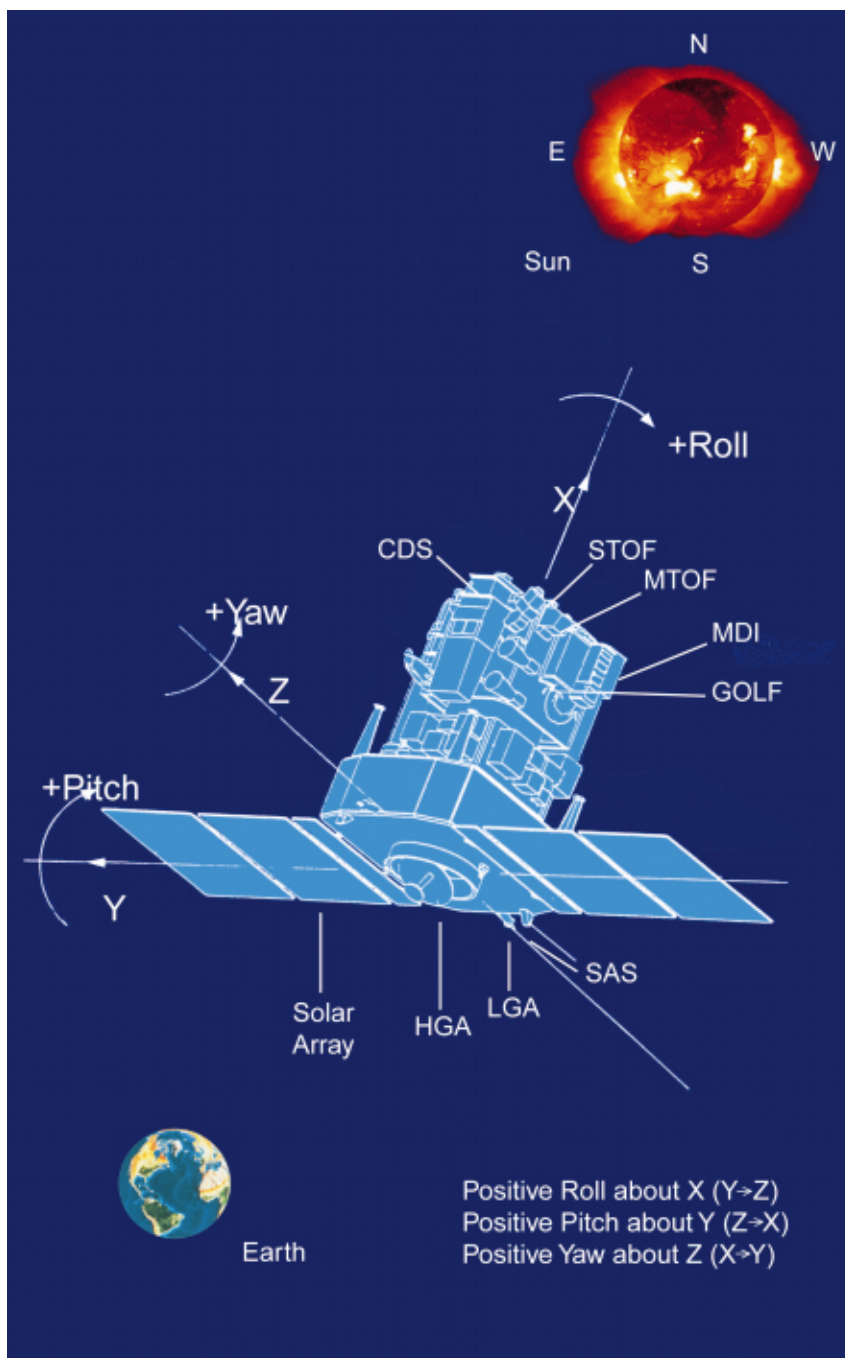
Figure 1. Rotational axes and sign conventions for SOHO manoeuvres

Spin-up continued with increasing 'coning' motion, producing increasing pitch/yaw off-pointing (Fig. 1) until the fine Sun-pointing anomaly detector triggered at a spin rate estimated at about 7 deg/s; the spacecraft then fell into ESR-7. The ESR-7 controller diverged at this spin rate, which greatly exceeded design values. This loss of attitude control ultimately resulted in loss of power, telemetry and thermal control.

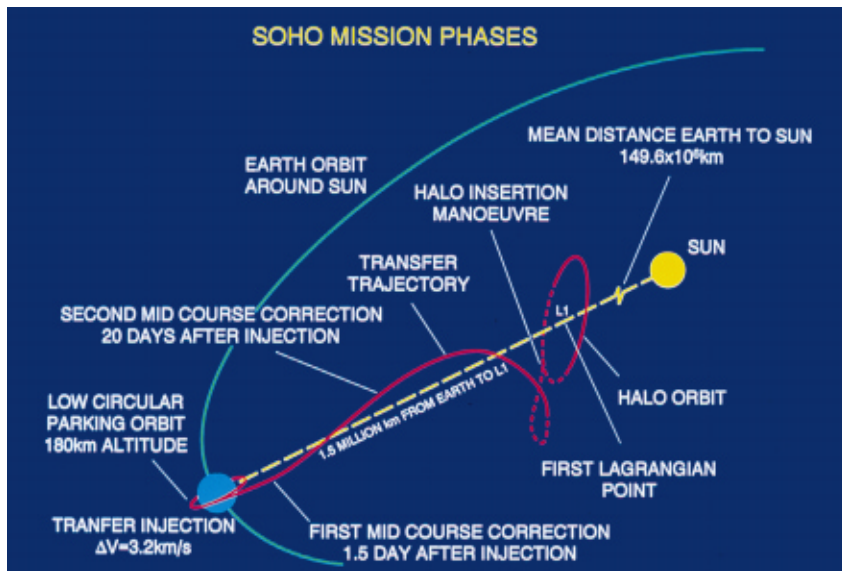
Figure 2. SOHO transfer trajectory and L1 halo orbit

SOHO's nominal trajectory is a halo orbit around the L1 Lagrangian point (Fig. 2), approximately 1.5 million kilometres from Earth. Halo orbits around L1 are inherently unstable and station-keeping (propulsive) manoeuvres must occasionally be used to stabilise them. If this reference trajectory is propagated from the point where SOHO's telemetry was lost and no additional delta-V is applied, it diverges only very slowly, retaining orbital halo characteristics up to mid-November 1998. Thereafter, the divergence would accelerate and eventually result in the spacecraft's escape into a solar orbit.

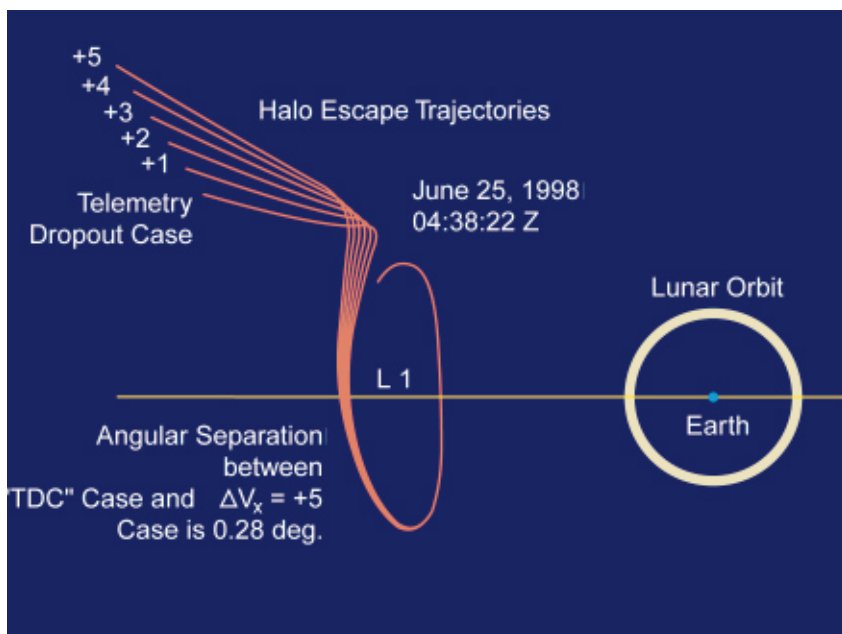
Figure 3. Computed potential halo escape trajectories, for delta-V's of 1 to 5 cm/sec

Several hypothetical trajectories based on post-loss delta-Vs were studied for delta-V's ranging from +1 to +5 cm/s (Fig. 3). The inertial orientation of the Z-axis would be moving by about  $1\text{deg/day}$  due to the global orbital motion of the spacecraft around the Sun near the L1 point. This implied that after roughly 90 days, the Z-axis would be perpendicular to the Sun, such that the solar arrays would face the Sun for half of the spin period. This meant that if SOHO was to be recovered, it had to be achieved when the Z-axis would be coarsely perpendicular to the Sun and before the end of November. Fortunately, the two conditions were compatible.
